Earthshots

Hubbard Glacier, Alaska, USA

Hubbard Glacier, Alaska, USA 1985-1986

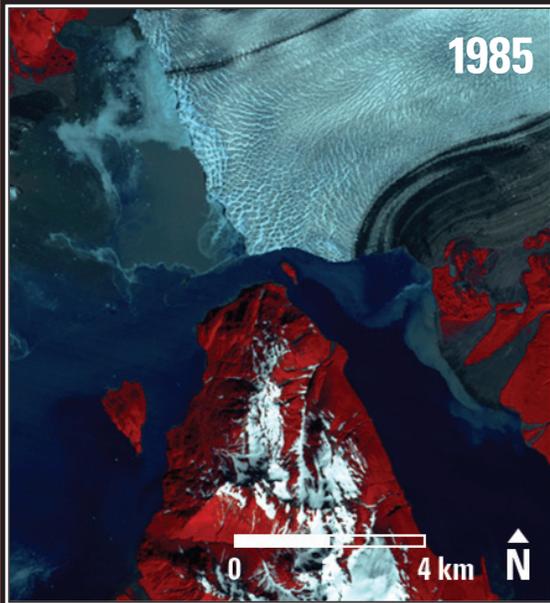
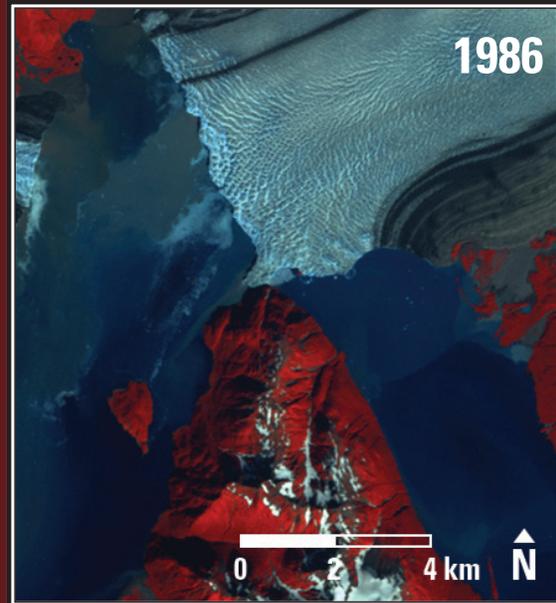
An unusual event on the coast of Alaska was observed with satellite imagery in 1986. A glacier slid down a valley and blocked a fiord from the rest of the bay. The fiord then turned into a temporary lake. The water's level rose 25 meters before the glacier dam gave way a few months later.

Date	Satellite	Bands	Res	Path	Row
Aug. 7, 1985	Landsat 5 TM	4,3,2	30 m	62	18
Sept. 11, 1986	Landsat 5 TM	4,3,2	30 m	62	18
